# NORTHRIDGE EARTHQUAKE: LIFELINE PERFORMANCE AND POST-EARTHQUAKE RESPONSE

Technical Council on  
Lifeline Earthquake Engineering,  
American Society of Civil Engineers

Edited by Anshel J. Schiff

April 1997

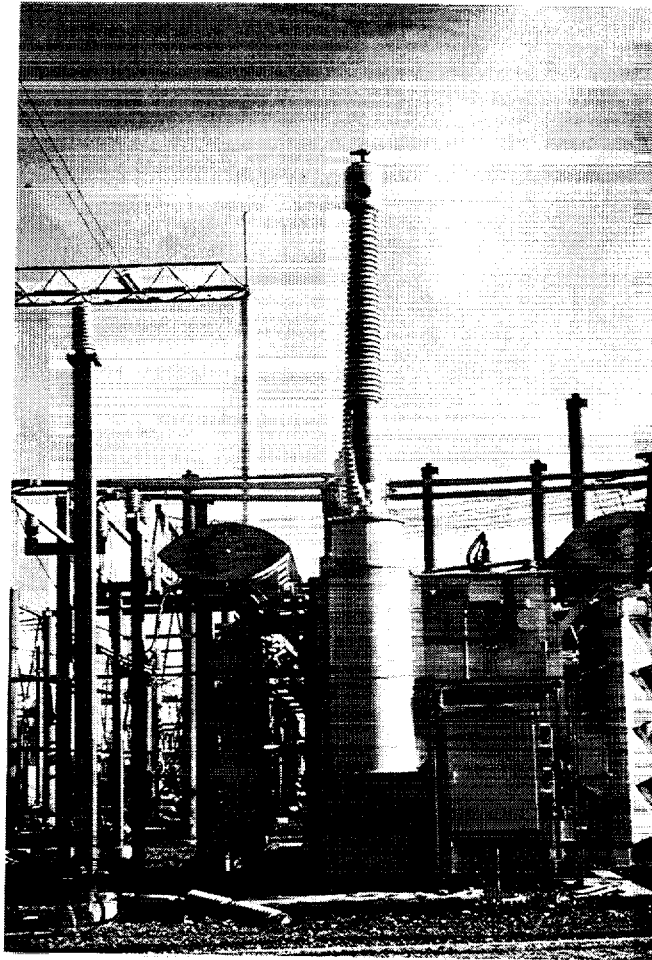
Approximately forty-two bushings required maintenance or had to be replaced in the main event and seven others were damaged in an aftershock. Four transformer bushing failure modes were observed: cracked porcelain, shifting of upper porcelain relative to its mounting flange, damage to bushing support or turret, and internal degradation of bushing. Two 500 kV bushings experienced massive failures to porcelain, Figs. 3.4 and 3.5. These failures were probably due to large loads associated with the dynamic response of the bushing. The natural frequency of the bushing mounting, including the contribution of the turret, and the site motion may have contributed to the porcelain failure and oil leaks. Interaction loads with connecting conductors probably did not significantly contribute to these failures.

Fig.3.4 Cracked 500 kV transformer bushing.

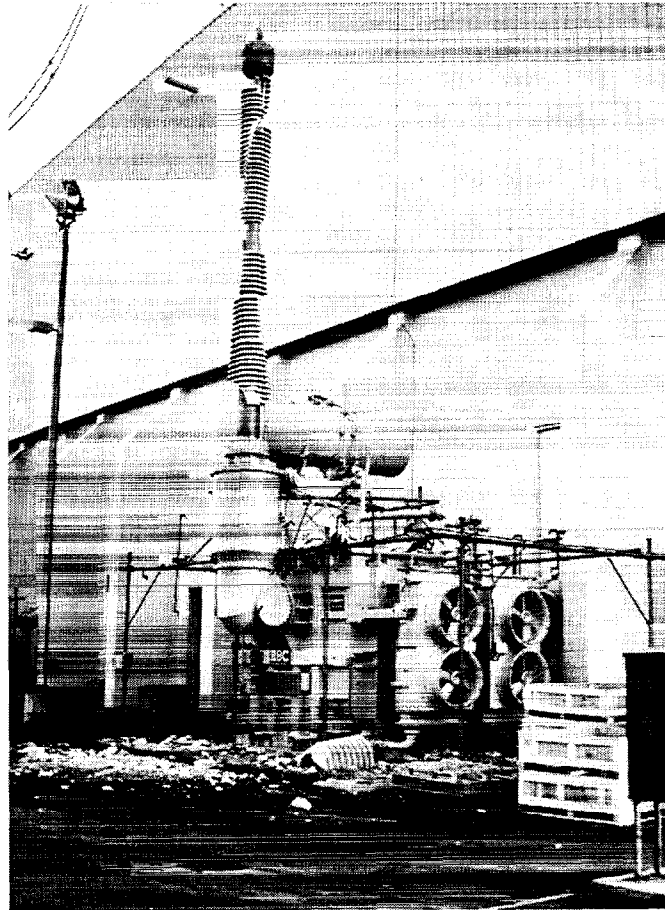
Fig. 3.5 Shattered reactor bushing.

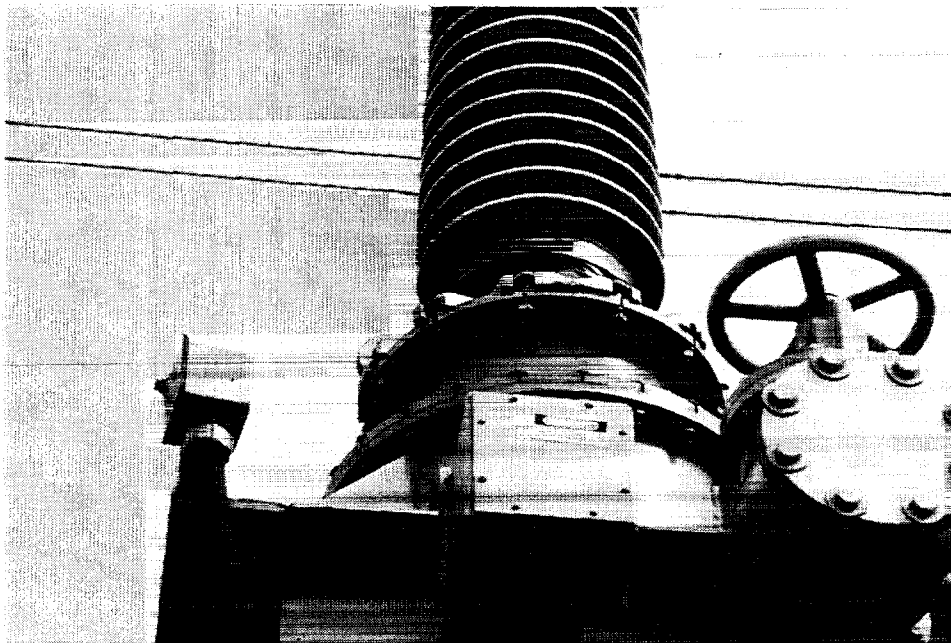
The second failure mode, which was much more common, was the rocking and slipping of the upper part of the transformer-bushing porcelain relative to its mounting flange, Fig. 3.6. In some cases the bushing re-seated itself and did not leak, but more often there was an offset and there were leaks at the interface between the porcelain and the flange. If the oil leak at the bushing is very small and the transformer is needed, it may be used with the leak until the units can be taken out of service and a repair made. Several factors contributed to these failures which were controlled by specific conditions at the transformer. Many failures were probably due to inertial loads imposed by the ground motion. In some cases, the flexibility of the turret, which

Fig.3.6 Transformer bushing with porcelain slipped relative to its mounting flange.

To repair a slipped bushing, it must be removed and restored at an appropriate maintenance facility, a lengthy process that can take about 6 weeks. To make a temporary repair to get the transformer back in service quickly, the oil around the base of the bushing is removed with a solvent and fast setting epoxy is applied to a thin wrap of linen around the porcelain-flange interface. If the leak persists, a vacuum line can be attached to the top of the bushing, and the cleaning and epoxy process repeated one or more times in an attempt to stop the leak. Bushings repaired in this way are then removed and restored when service conditions permit.

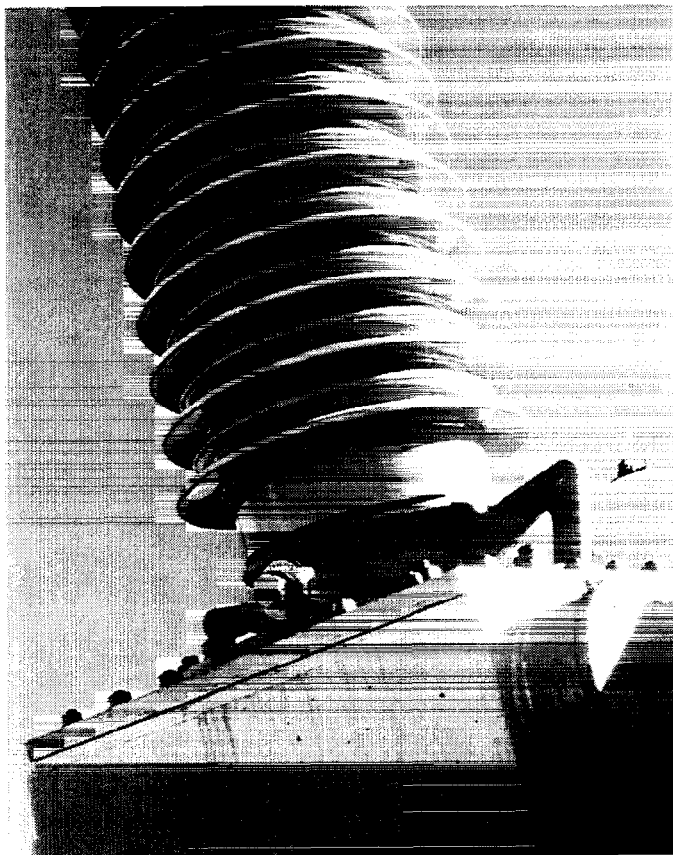
The third failure mode was the failure of the bushing support flange or turret. The failure of the flange support shown in Figs. 3.7 was probably due to a flaw in the casting, as this type of failure has not been observed before. The failure of the turret anchor bolts shown in Fig. 3.8 on a spare transformer was caused by the overload.

Fig.3.7 Fractured transformer bushing flange support.

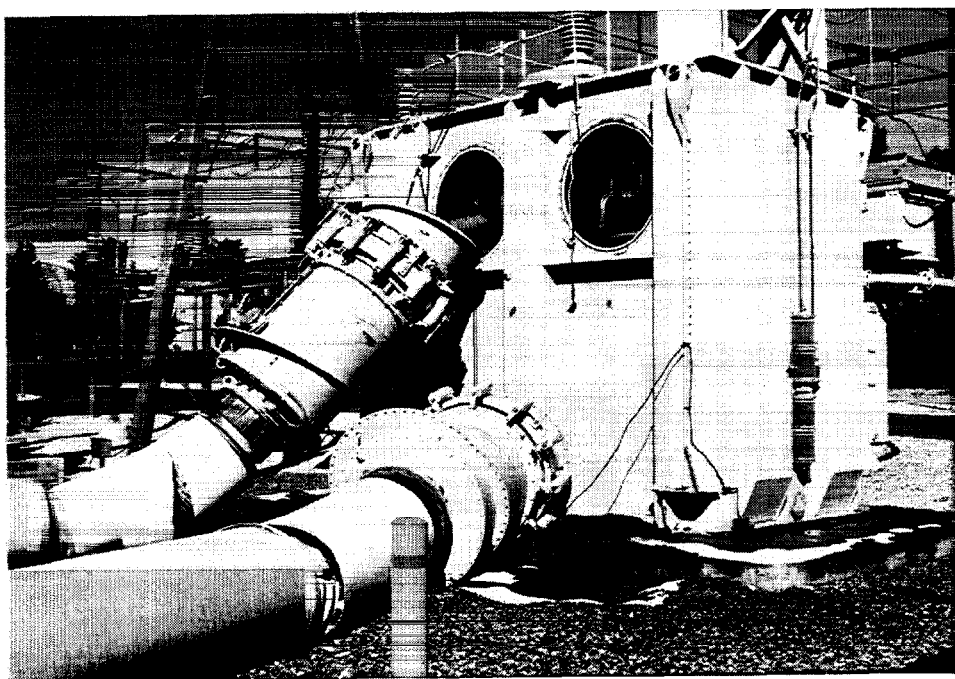
Fig.3.8 Bushing-turret mounting-bolts failed.

When installed, the turret is supported by the wall that the turret penetrates. The peak vertical acceleration recorded at this site was 0.83 g, well above the 0.5 g design value.

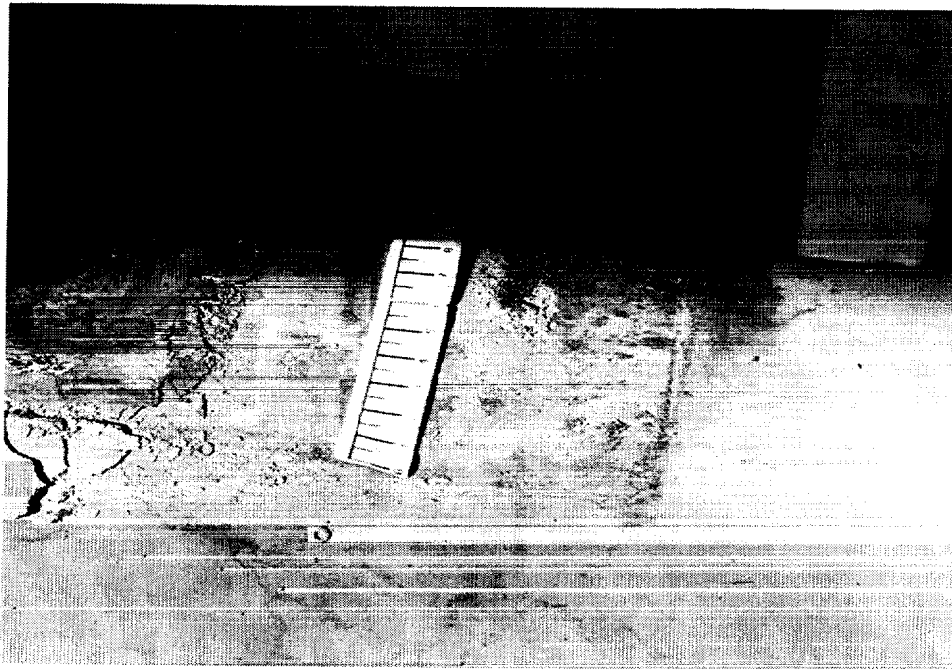
Fig.3.10 Transformer weld failed and transformer moved 14".

retrofit to the transformer shown in Fig. 3.10 is shown in Fig. 3.12. The base plate is held to the pad by four studs held with epoxy in holes in the pad. The base of the transformer is also welded to the anchor base plate. The original welds between the bottom of the transformer case and embedments in the foundation pad were also replaced with heavier welds. Figure 3.13 shows retrofits to transformer anchorage that showed signs of distress to ground motions of 0.15 g.

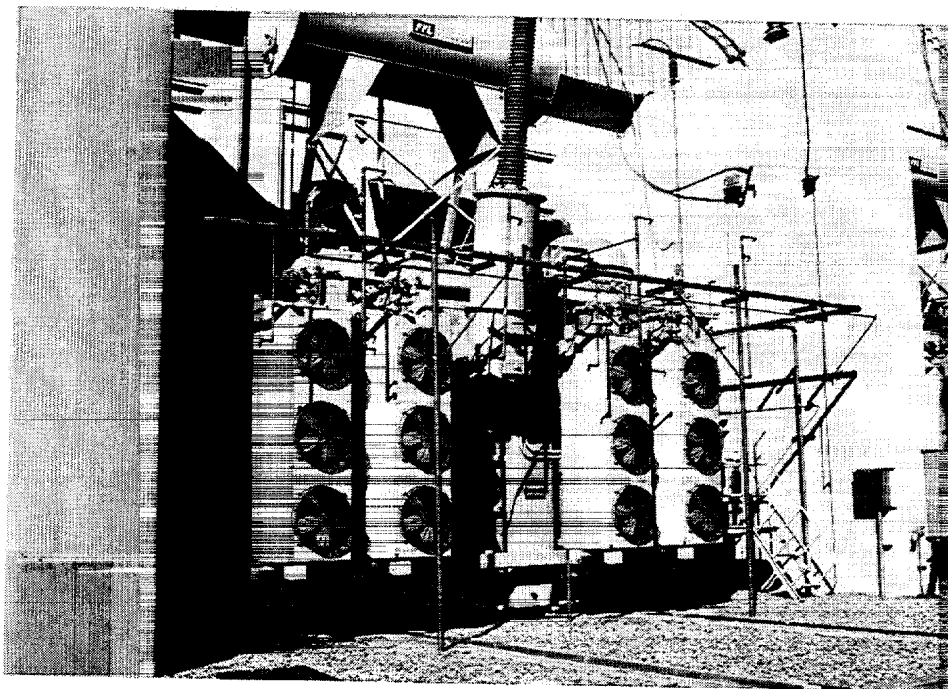
Fig.3.11 Large transformer stretched and deformed its 2" anchor bolts.

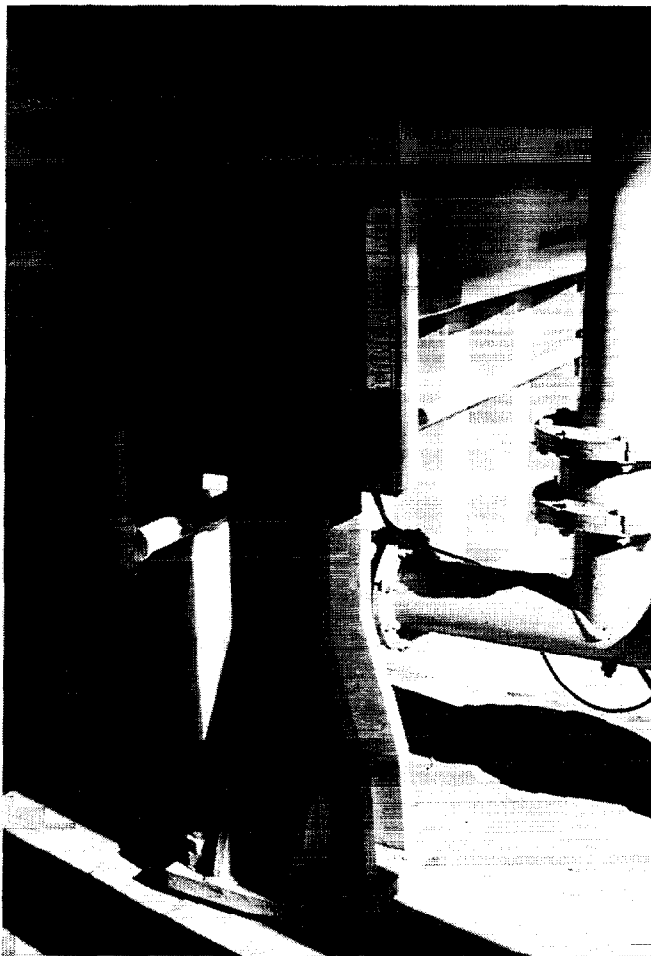
The concrete around embedded plates in transformer pads at a low acceleration site (0.15 g) developed cracks. As a precautionary measure the anchorage has been strengthened. Most of the modifications to strengthen anchorage have connected the

Fig.3.13 Distressed anchorage strengthened with linkage to existing tab.

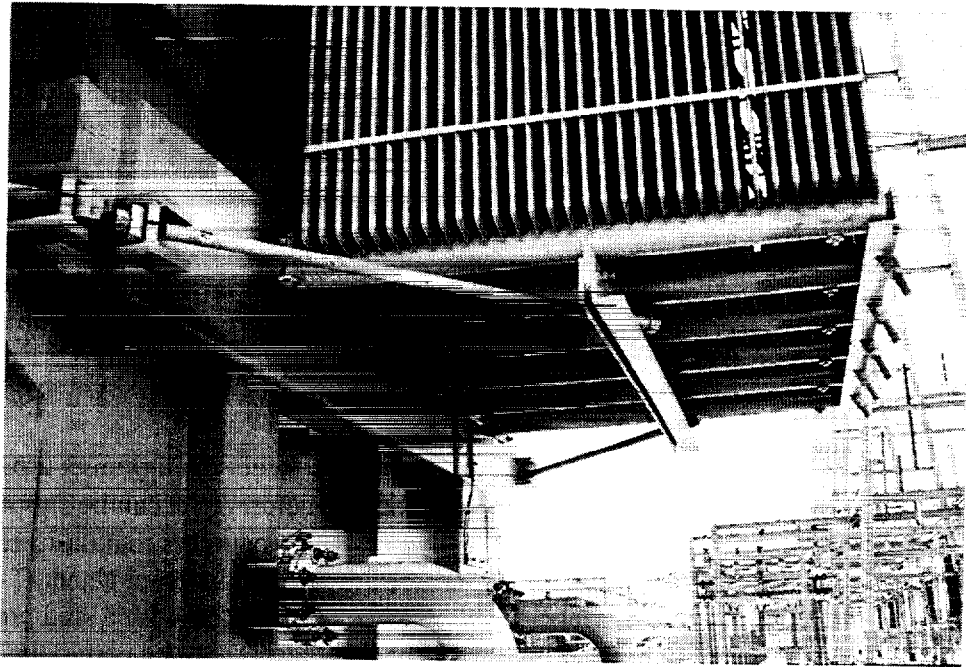
In this earthquake, large, single-element radiators caused some pipes to crack where they are connected to the transformer body. This occurred at a site with a peak ground acceleration of only 0.15 g. These radiators have been retrofitted by adding bracing at the top and bottom to increase lateral stiffness of the radiators and diagonal braces from the top of the transformer to the radiators to improve vertical support, Fig. 3.15.

Fig.3.15 Diagonal bracing added to radiators to reduce moments on pipe connections.

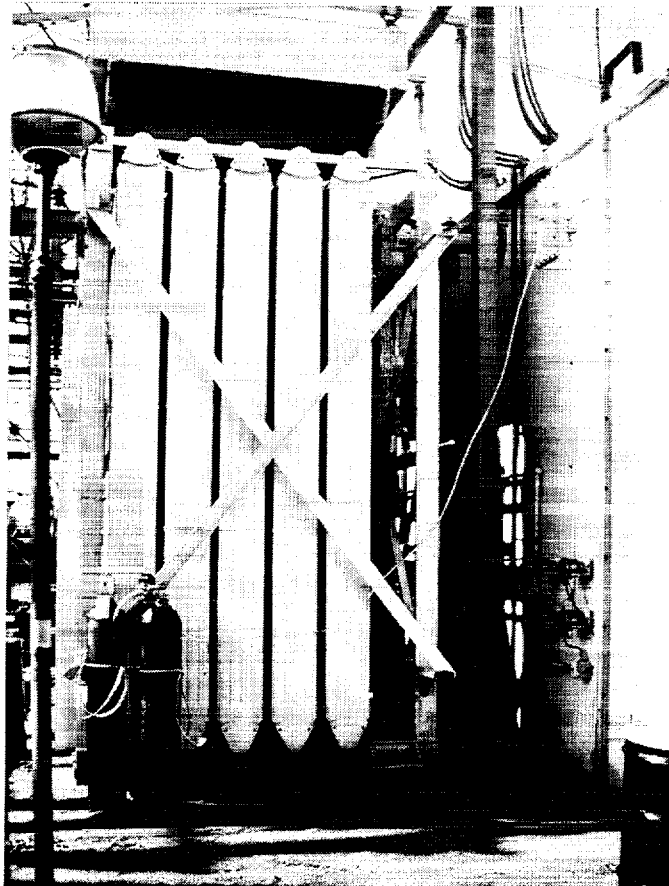
Substations located adjacent to residential areas often have acoustical enclosures for transformers. When this is done, the radiators are typically located outside of the enclosure and are self-supported, Fig. 3.16. In one case, the motion of the radiator

Fig. 3.16 Self-supporting radiator outside of acoustical transformer enclosure.

relative to the transformer caused the Dresser coupling between the transformer case and the top of the radiator to fail.

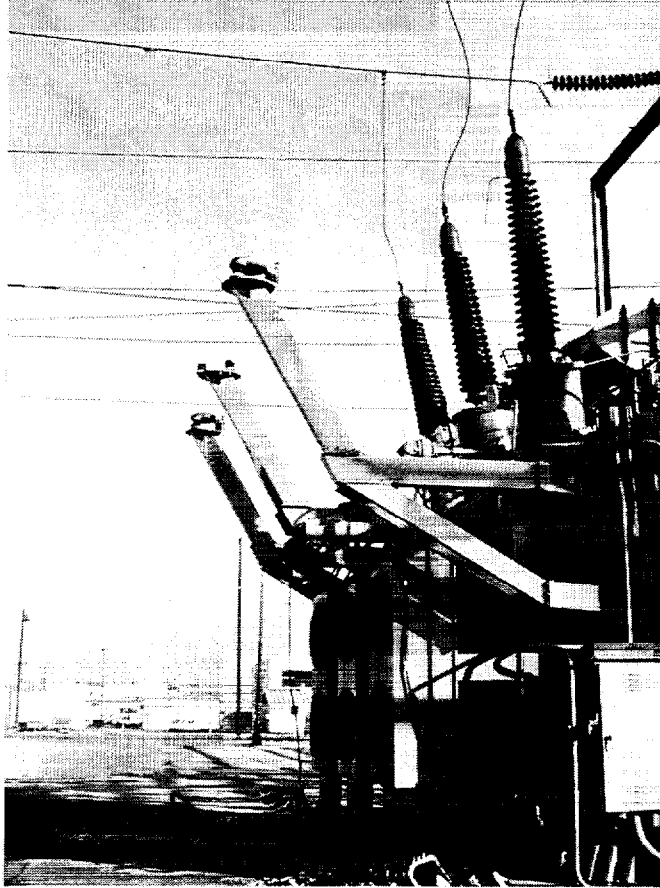
Lightning arresters have two failure modes: the standoffs fail or the body of the lightning arrester fails at the lower porcelain-flange interface. Figure 3.17 show the A and C phases failed in the body of the lightning arrester and the B phase failed at the standoffs. Lightning arresters are one of the most vulnerable items in a substation. Boom-supported and frame-supported units are the most vulnerable and the amplification of the support structure probably contributes to their failure. In many situations, interaction loads from conductors contribute to the failure. About half of the failures are in the standoffs and half in the body of the lightning arrester.

Fig. 3.17 Lightning arresters were supported on boom off of transformer failed at standoff or body of lightning arrester.

Damaged lightning arresters are typically cut from the line and the transformer put back into service without the lightning arrester. In California, lightning storms are relatively rare. In regions with frequent thunder storms, utilities may not take the risk of operating without lightning arresters.

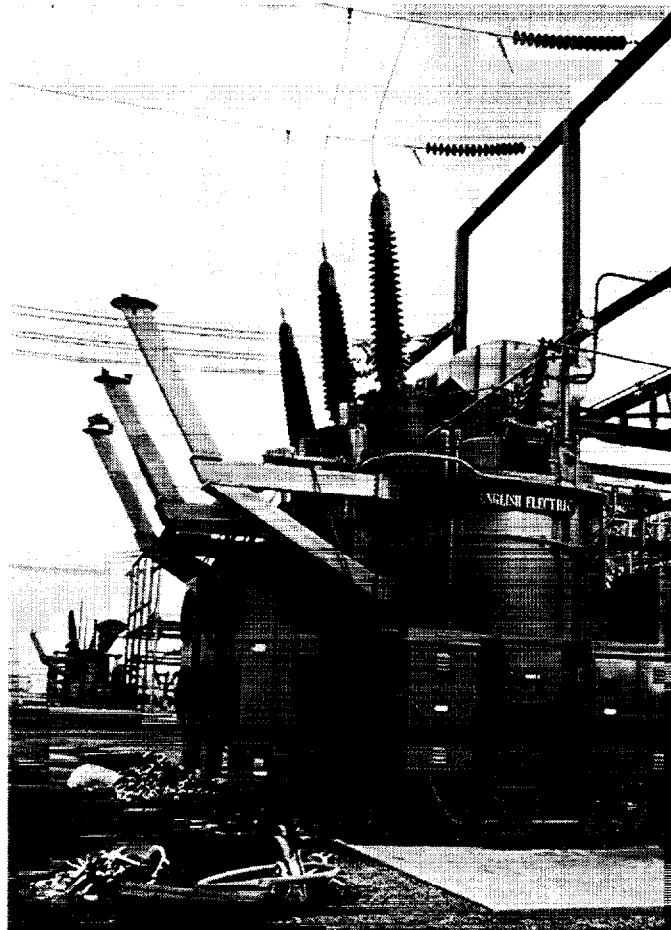
As noted below, lightning arresters can be removed and the system can continue to operate. The failure of the lightning arresters could have a serious impact, however. Some lightning arresters are positioned near the bushing so that if it failed, it could hit and damage the bushing. There are two ways to connect the lightning arrester to the system: a conductor directly to the bushing, or a conductor to the conductor connected to the bushing. Figure 3.18 shows the A and C phase lightning arresters connected to the bushing conductor and the B phase connected directly to the bushing. This was done because of lack of clearance due to the orientation of the overhead conductors. When the lightning arrester is connected directly to the bushings, it will have a tendency to fall towards the bushing if it fails. Even if it does not strike the bushing, the impact of the falling lightning arrester can damage the bushing conductor mounting hardware, Fig. 3.19.

Fig.3.19 The bushings mounting post was bent when lightning arrester failed, fell, and conductor pulled on post .

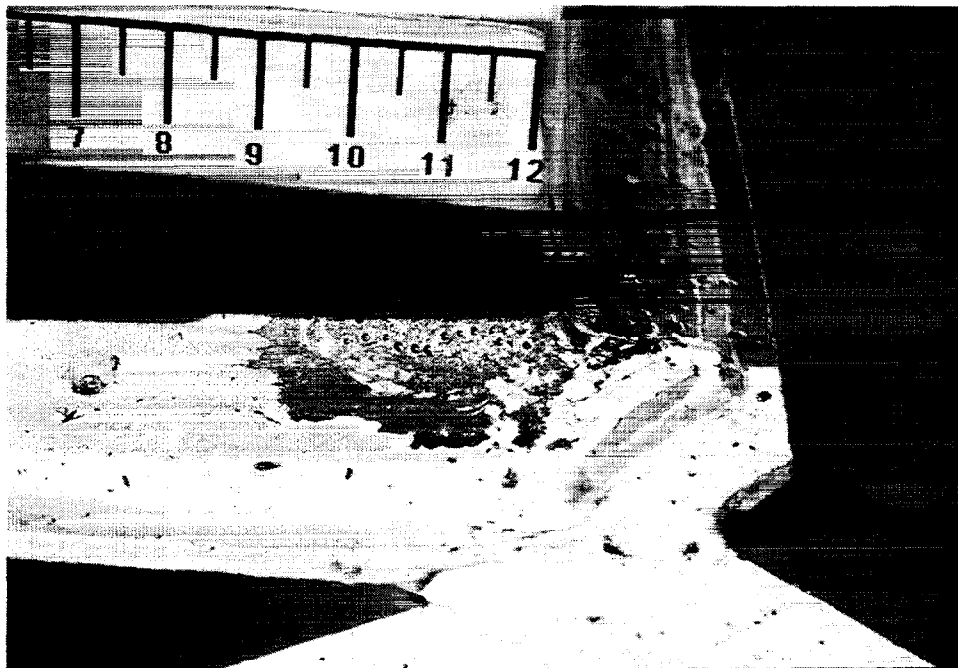
At one site with moderate ground motion, welds used to fabricate the transformer case cracked, causing a minor, but persistent leak, Fig 3.20. The leak was stopped by using a center punch to make indentations on each side and adjacent and parallel to the crack moving metal to close the crack.

Fig.3.20 Earthquake induced stress caused a weld to crack and leak oil.

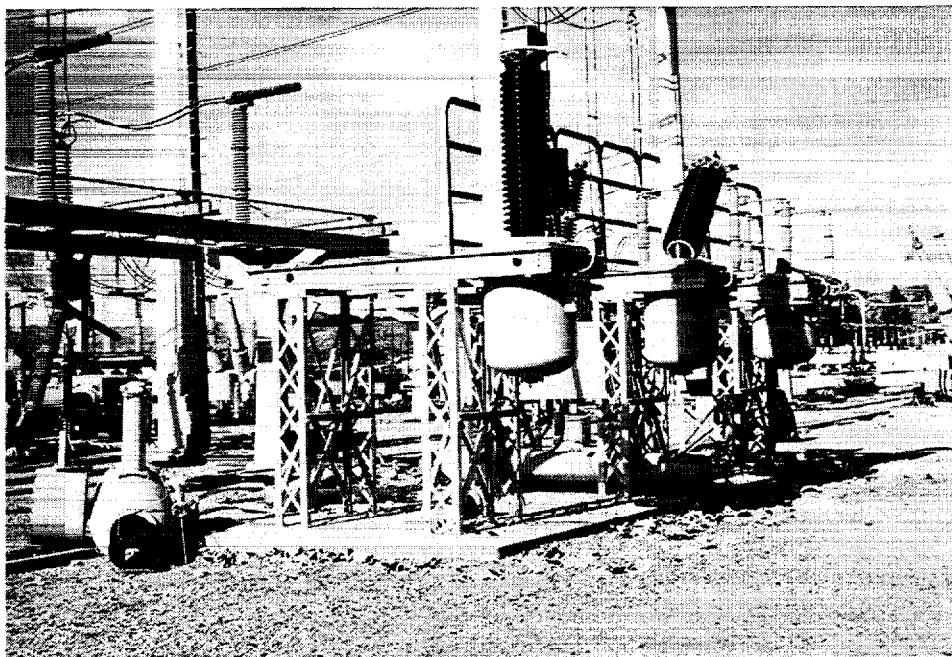
The performance of older live-tank breakers in this earthquake was consistent with past performance. That is, these units failed when subjected to moderate earthquake motions and were damaged or failed in small ground motions. Two designs were severely damaged by ground motions with a peak acceleration of 0.56 g, Figs. 3.21 and 3.22. The units shown in the right side of Fig. 3.22 are of the design that failed.

Fig. 3.21 Life-tank circuit breakers support the heavy interrupter head on a porcelain column that frequently fails.

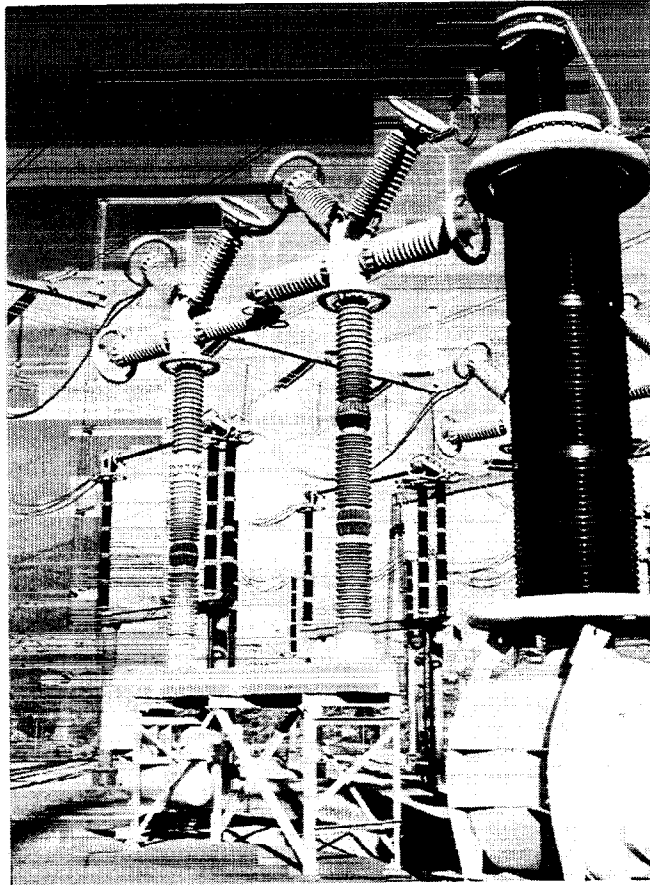
Fig.3.22 Leaking live-tank column gasket will cause a loss of pressure that will prevent the circuit breaker from operating.

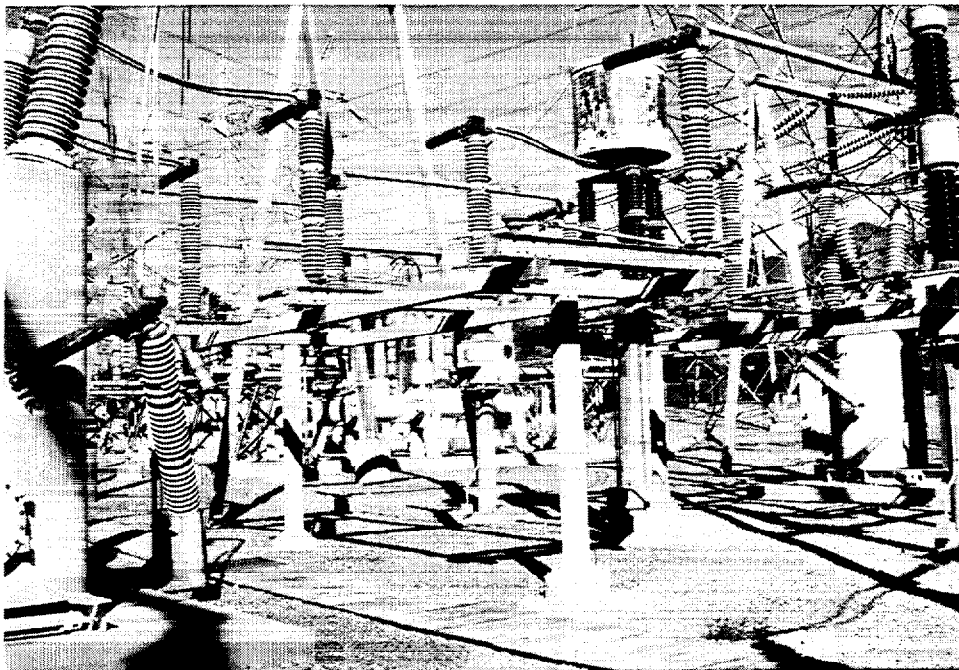
Disconnect switches failed from one of five failure modes in this earthquake. The most common is the failure of one or more of the post insulator columns used to

Fig. 3.25 The most common disconnect switch failure is the fracture of post insulators.

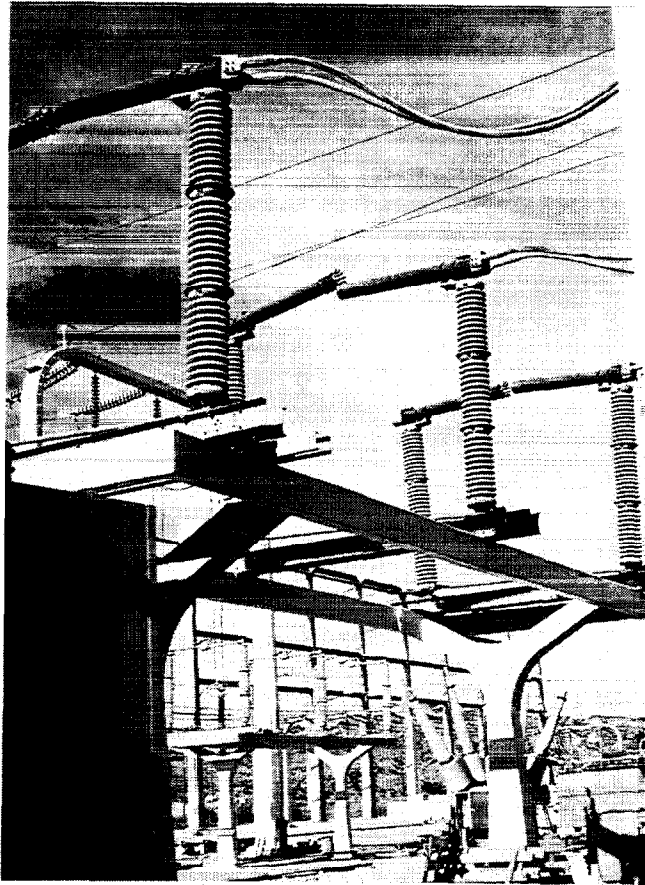
Fig.3.26 Deformation of the plate supporting the post insulator stack prevented disconnect switch from closing.

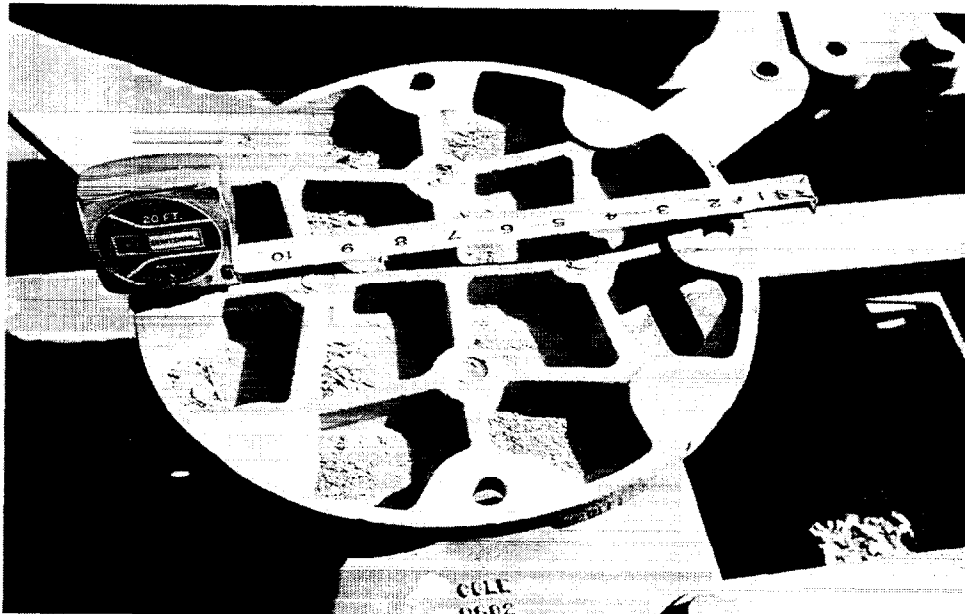
Fig. 3.27. The deformation of the cast aluminum base plate has not been seen in other earthquakes.

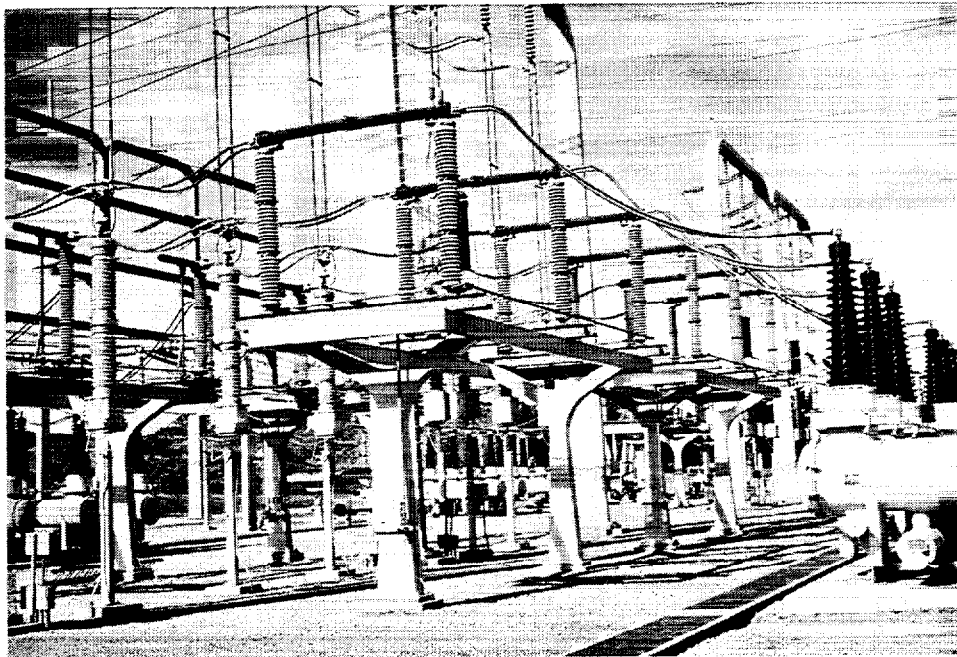
Fig.3.28 An emergency operating procedure uses cotton rope to hold the disconnect switch arms together.

There were two emergency response actions taken to restore disconnect switch function, that is, to make contact across damaged disconnect switches. Because of the large number of damaged post insulators used to fabricate switches, it was common to cannibalized partially damaged switches or bus supports to get replacement post insulators. In one switch design, the stack of post insulators is tapered, that is, the insulators at the top are smaller than those at the bottom. Since the lowest insulator typically fails, there was a shortage of this particular element. While a flexible conductor could have been used to jump across a switch, none of these were observed. A second emergency procedure was to use cotton rope to hold deformed disconnect switch parts together to complete a connection so that service could be restored, Fig. 3.28.

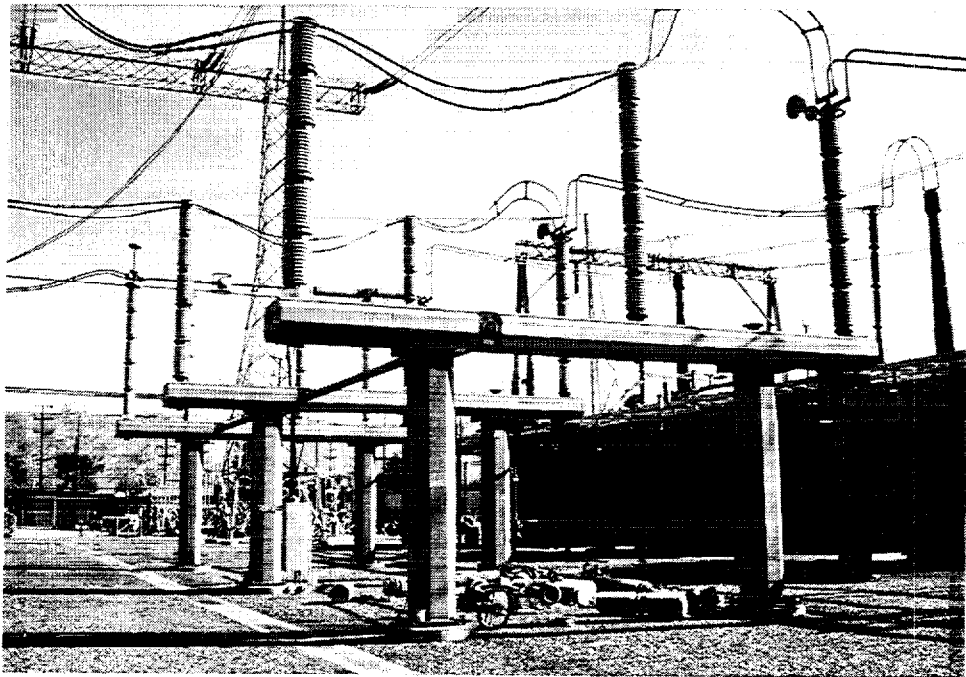
Circuit switchers at several sites were severely damaged. At one location, where they connected a transmission line to transformers, conductor was strung across the damaged circuit switchers to restore service, Fig 3.29.

Fig.3.29 Emergency procedure is shown stringing conductor across damaged circuit switchers to connect a transmission line to a transformer bank.

Because of the inability to find circuit switchers that meet current seismic specifications, the plan is to replace these devices with circuit breakers and disconnect switches.

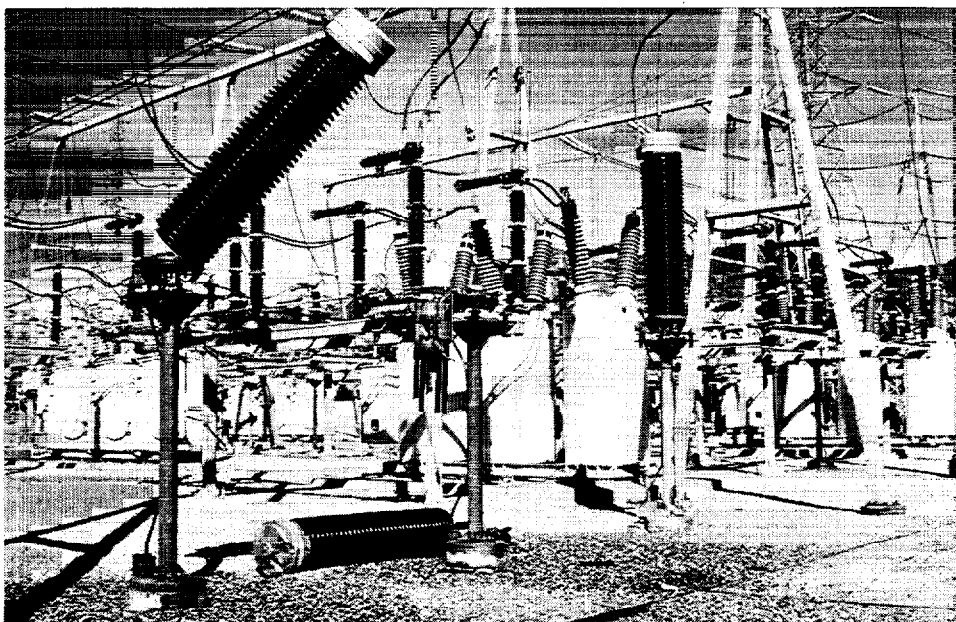
Potential transformers, current-voltage transformers, and some current transformers have similar structural forms, that is, they have long cylindrical porcelain members supported on steel columns or suspended from above. Units supported from below frequently failed where the porcelain joins its lower mounting flange, Fig 3.30. Some units supported from below used Bellville washers to change frequencies and/or increase damping. The performance of these units was mixed. Units with stiff (above about 8 Hz.) steel support columns performed well while those with standard columns with frequencies below 6 Hz. frequently failed. Suspended units had a different failure mode. The lower aluminum angle restraint anchor attachments on many of these units failed, and their swinging motion tended to damage low voltage electrical connections, Fig 3.31. The violent character of these motions is indicated by damage to the anchorage of restraint columns, Fig. 3.32. A review of the damage pattern suggests that the length of the suspension system influenced the response, so that there may have been a tuning of the system to the ground motion. Even in units where lower restraints did not fail, adjacent equipment was damaged in about 25% of the cases due to interaction effects. When the lower restraints failed, the damage to adjacent equipment rose to 78%. The damage associated with more massive suspended items, such as wave traps, was about three times that associated with lighter suspended items, such as current-voltage transformers. It is interesting to note that the porcelain on suspended units is seldom damaged.

Fig. 3.30 Porcelain of a potential transformer failed at its lower support.

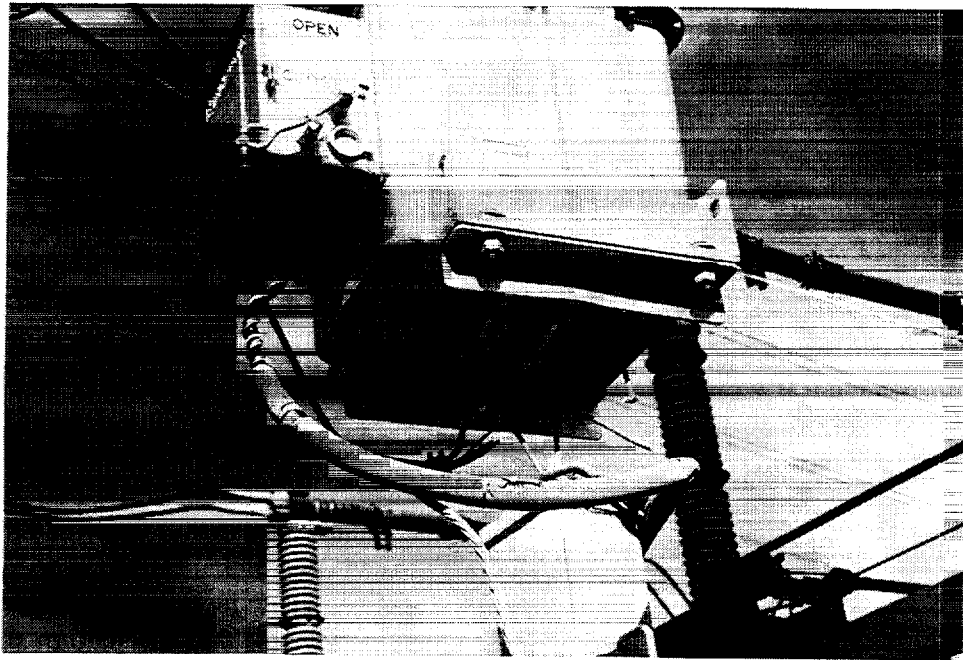
Fig. 3.31 Aluminum angle used to restrain suspended current-voltage transformers frequently failed.

When damaged current-voltage transformers are typically removed from the system and the system continues to operate. Suspended units with damaged restraints were often temporarily restrained with rope.

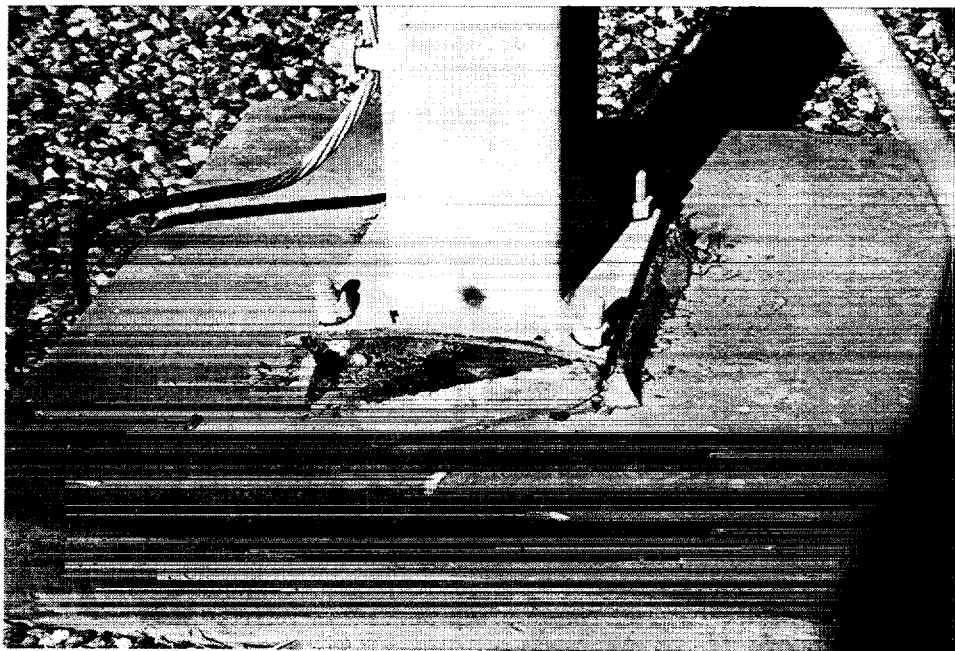
Fig. 3.32 Violent motion of suspended current-voltage transformers damaged base of column restraints.

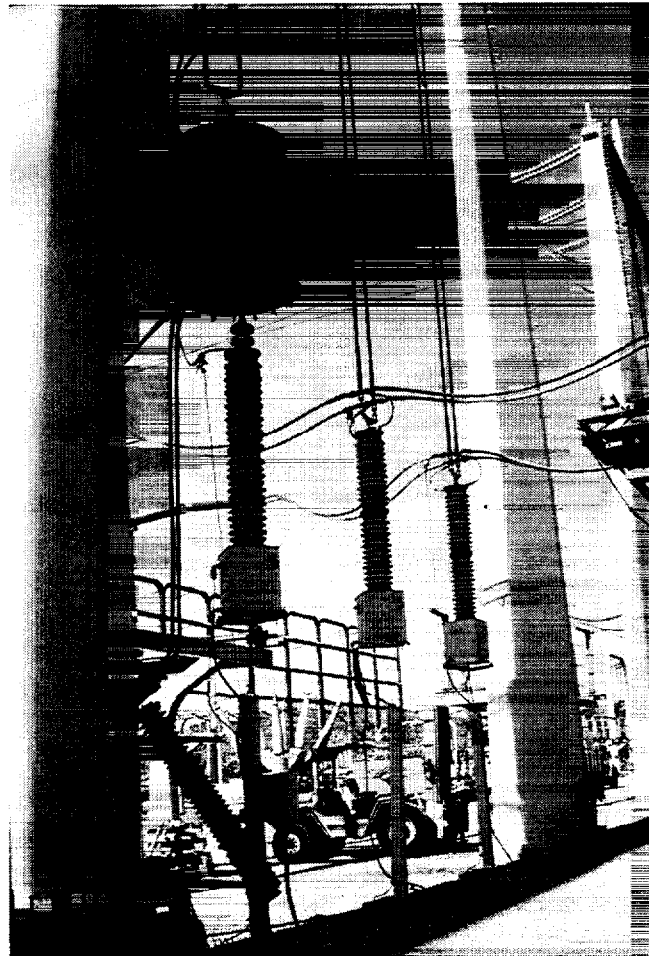
The performance of suspended units in this earthquake has been good, in the sense that most units were not damaged. However, their swinging motion often caused severe damage to adjacent equipment, Fig 3.33. Two suspended units had internal structural failures and fell to the ground. Support post insulators on units supported from below frequently fail, Fig. 3.34, or structural connections above the post insulators fail, Fig 3.35. Failures were often in aluminum bolts.

Fig. 3.33 Motion of a suspended wave trap damaged an nearby disconnect switch.

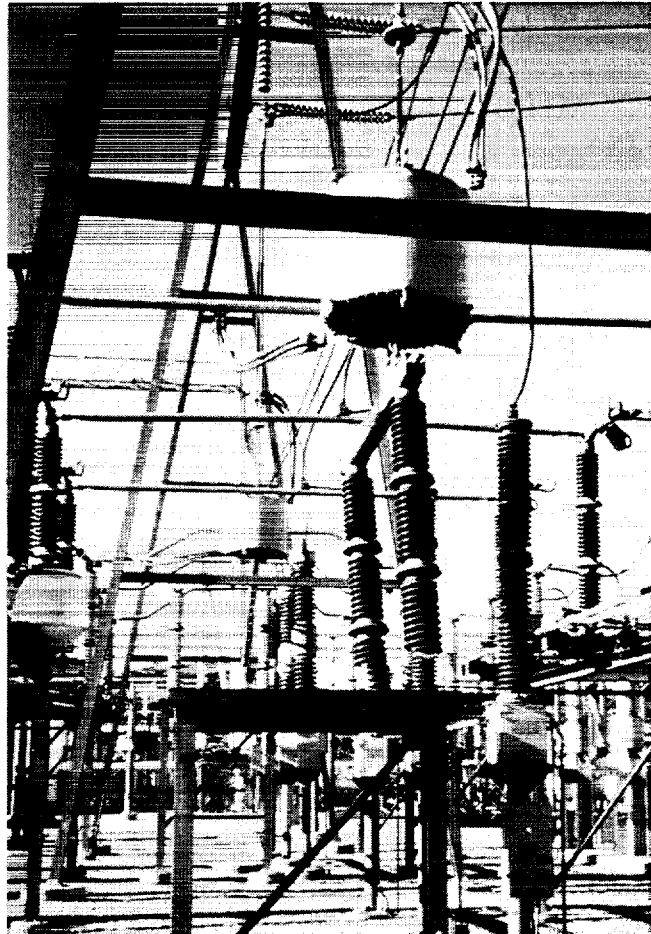
Fig.3.34 A 230 kV suspended wave trap failed post insulator restraints below the wave trap.

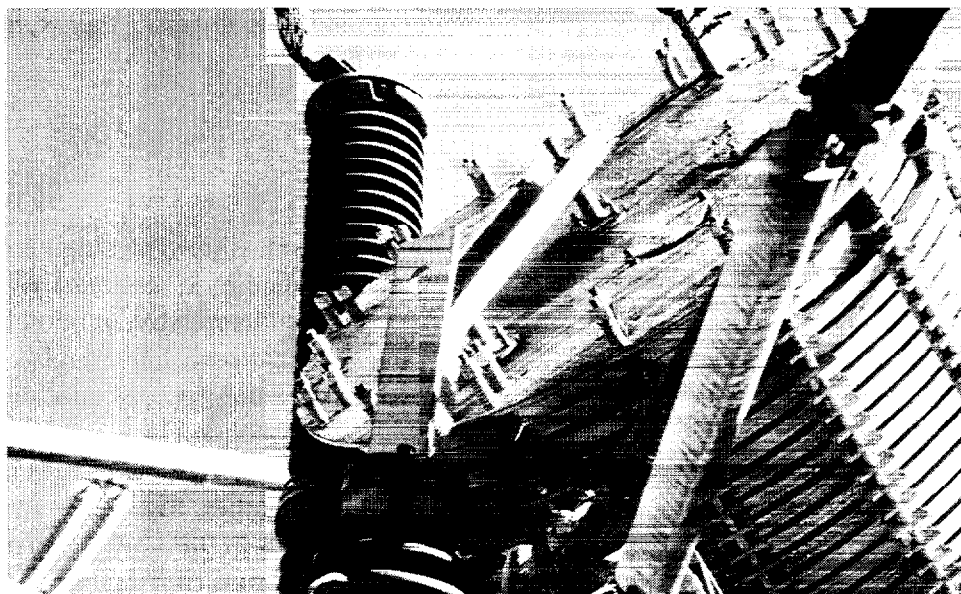
Fig.3.35 Channel supporting wave traps failed just above the weld to the top of the post insulator.

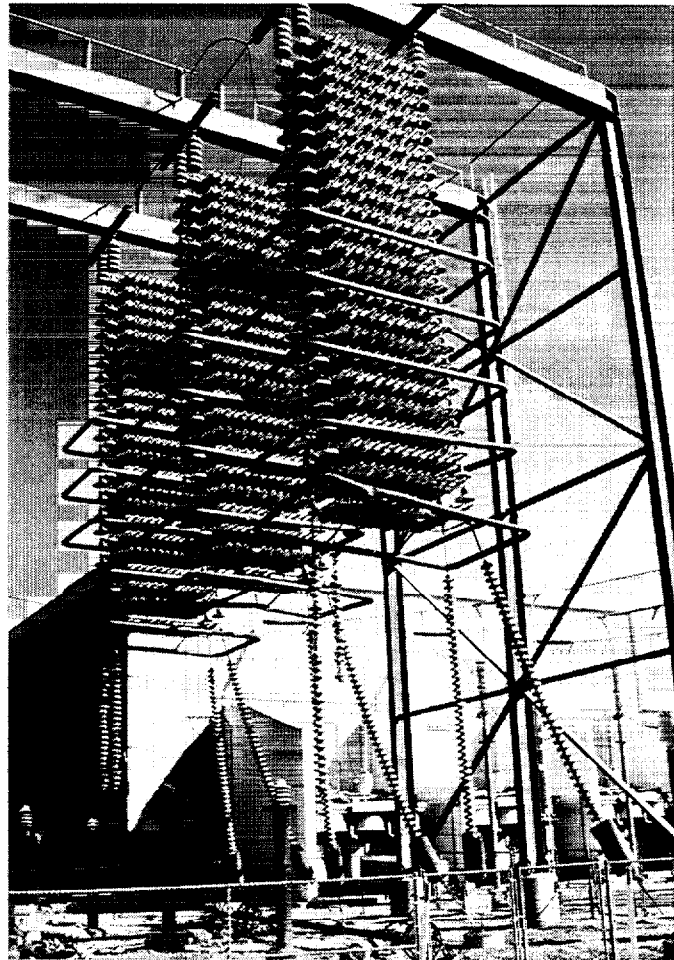
structure welds, had been replaced and were not damaged in this earthquake. Harmonic filter capacitors associated with Valve Hall 7 and 8 at Sylmar West were added after 1971. These capacitors were suspended, and in the earthquake broke their lower restraints, but were otherwise undamaged, Fig. 3.36.

Fig. 3.36 Suspended harmonic filter capacitors failed their lower restraints, but were otherwise undamaged.

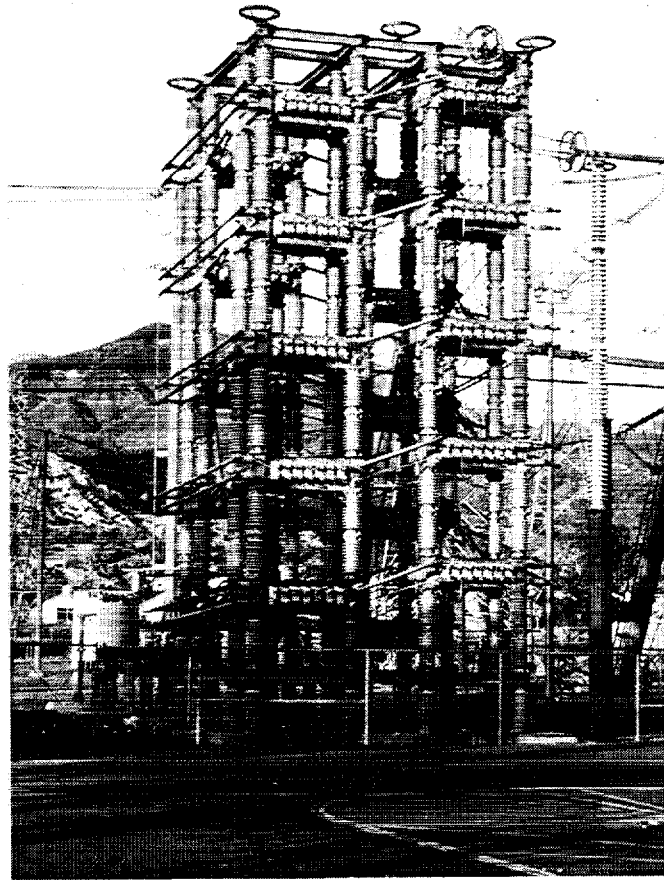
Harmonic filter capacitors at Sylmar East were in a support structure made of post insulators. In the earthquake several post insulators fail, but the structure did not collapse, Fig. 3.37. The power factor correction capacitor racks are of different sizes to meet different electrical requirements. The base support porcelain members of the tallest racks at two locations on the site failed, Fig. 3.38. It is not known if the structural frequency was coincident with spectral content of the ground motion or if the taller structure overloaded its supports.

Fig. 3.37 Harmonic filter capacitor support structure was damaged, but did not collapse.

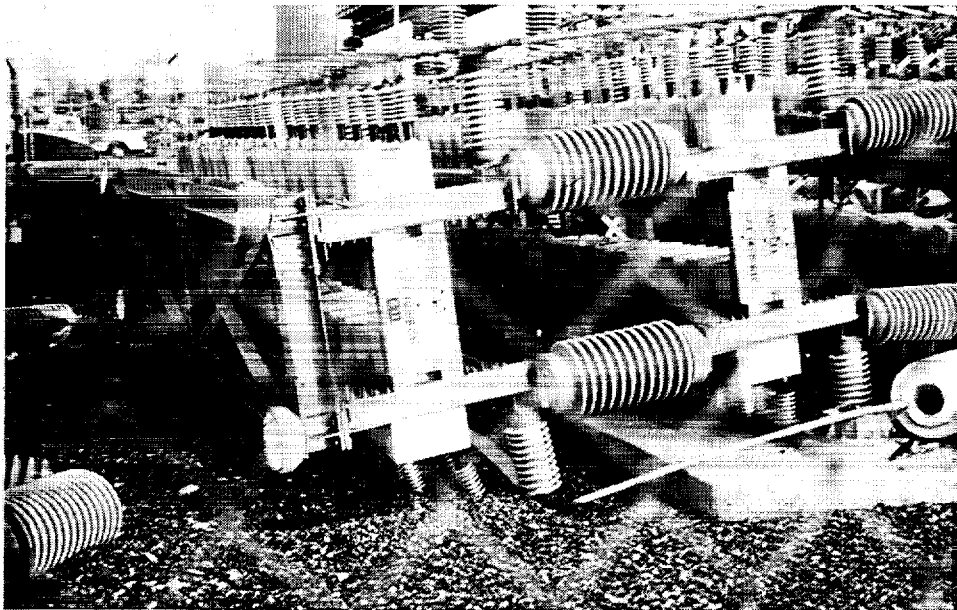
Fig. 3.38 The lower post insulators on the tallest power factor correction capacitors failed.

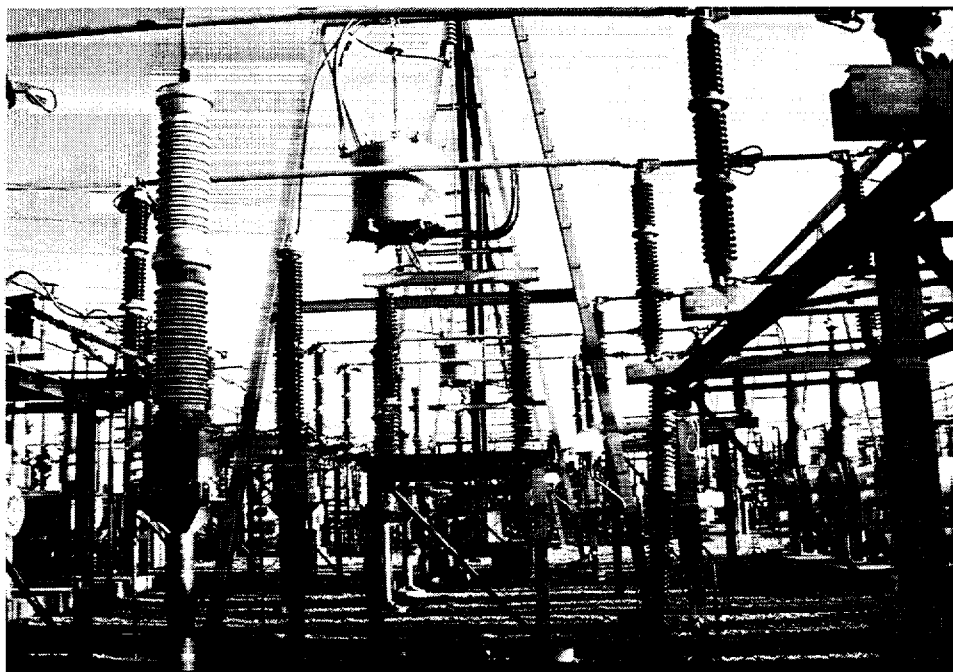
made with a rigid bus. There were indications that this rigid connection contributed to disconnect switch failures. Existing systems are being modified by adding flexible connections to the switches and new construction will use all flexible conductor with generous slack. In general, more generous use of slack in conductor connections between equipment will be made.

Fig. 3.40 Rigid bus used to connect disconnect switches at line drop contributed to disconnect switch damage.

One utility plans to replace its rigid bus with flexible bus. Also, at bus drop to rigid bus between disconnect switches will be modified by adding flexible links at the end of
